Report on extant historic fabric at 857 Riverside Drive, New York, NY

1. Introduction and summary

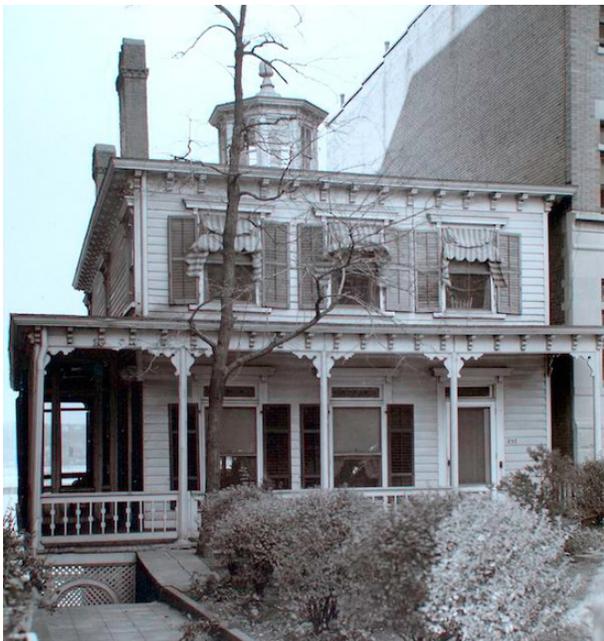
Figure 1 Bernice Abbot photo 1930 showing decorative window surrounds

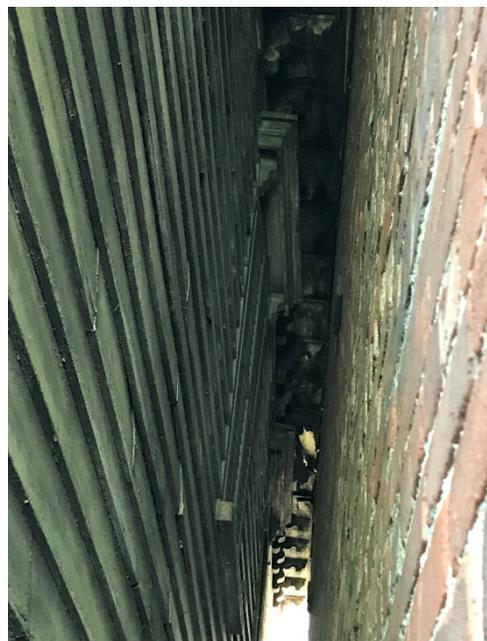
The exterior of the building retains its historic exterior wooden clapboard largely intact. The north façade, due to the later construction of the adjacent building, has been entirely preserved with all cladding, roof brackets, and two windows of the second story (fig. 2). These windows retain their original decorative cornices, brackets, and swinging shutters (figs. 2 & 3). Below these two windows there appears to be the remnants of a third window, perhaps a former light into the existing stairwell, which was covered over at some point leaving only the sill in place.

Figure 2 North façade showing preserved window surrounds, shutters and clapboard

- Restoration of lost window cornices based on existing examples on the north façade and historic photographs
- Installing period appropriate wooden windows and door

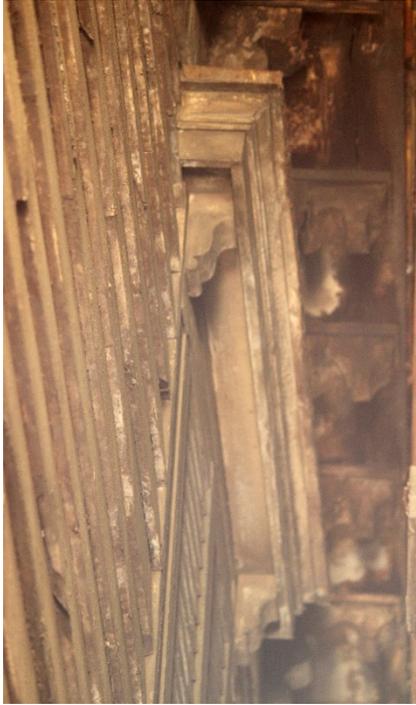
Figure 3 Detail of remaining historic window surrounds and roof brackets, north façade.

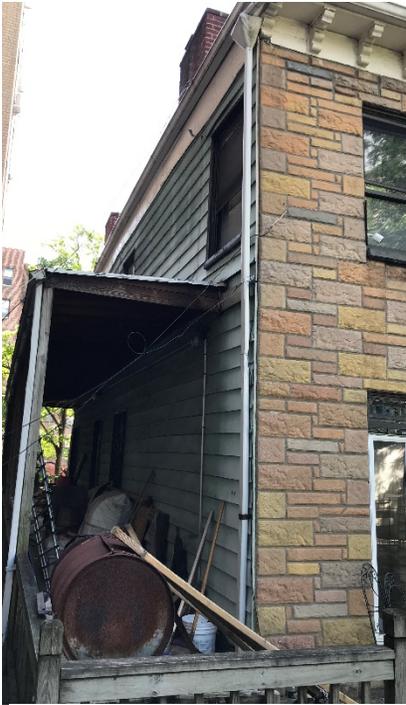
Figure 4 South façade detail showing original clapboard covered in siding.

On the southern and western facades, the same clapboard is preserved below layers of siding (fig. 4). On these facades, the decorative window cornices were likely removed to accommodate the siding, but the wooden sills remain in place covered by modern anodized aluminum. The eastern street-facing façade is covered in a faux stone finish applied in the 1990s. The faux stone is superficial and not an impediment to restoring the structure, while the existing window frames on the north façade and historic photos offer a model for restoring lost window cornices. The entire building retains the historic roof brackets below overhanging wooden eaves (figure 5).

- Removal of modern siding materials to reveal the condition of the historic clapboard
- Stabilization, repair and painting of existing roof brackets, clapboard, and remaining window frames
- Any necessary repairs to the foundation and roof

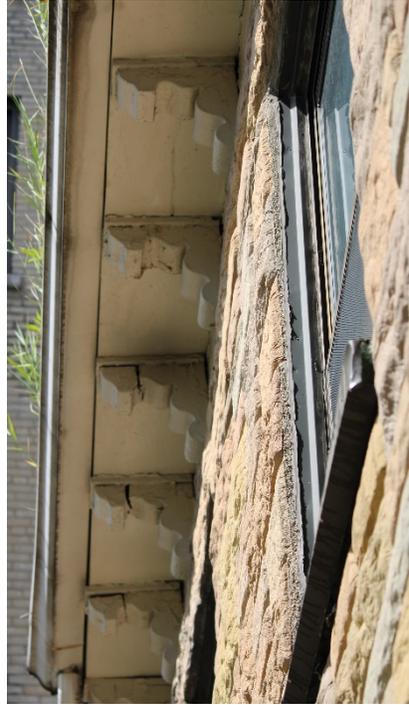
Figure 5 Detail of roof brackets and eaves

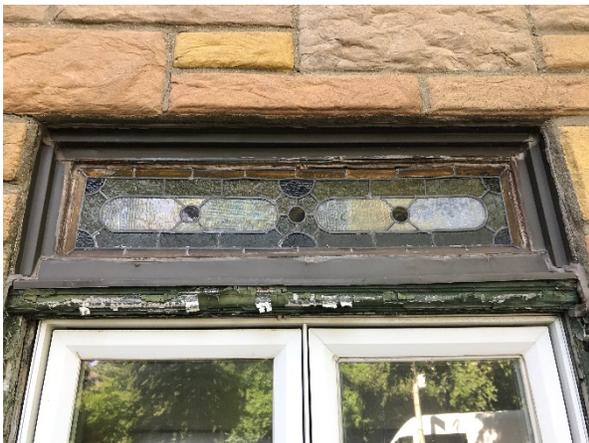
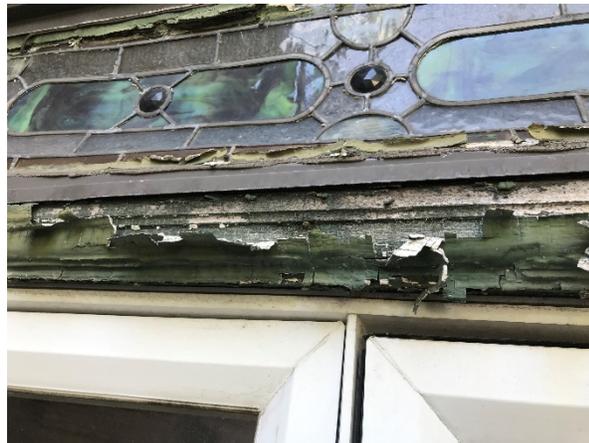
All windows were replaced by the time of the 1937 Bernice Abbot photo and have been subsequently modernized again. The current window and door openings however are largely the same configuration as in historic photographs. Historic stained glass transom windows remain on the lower front windows and door. These windows retain historic wooden frames, painted in green (figures 6 & 7).

Figures 6 & 7 Four stained glass transoms may date to circa 1900, with potentially earlier wooden frames (in green).

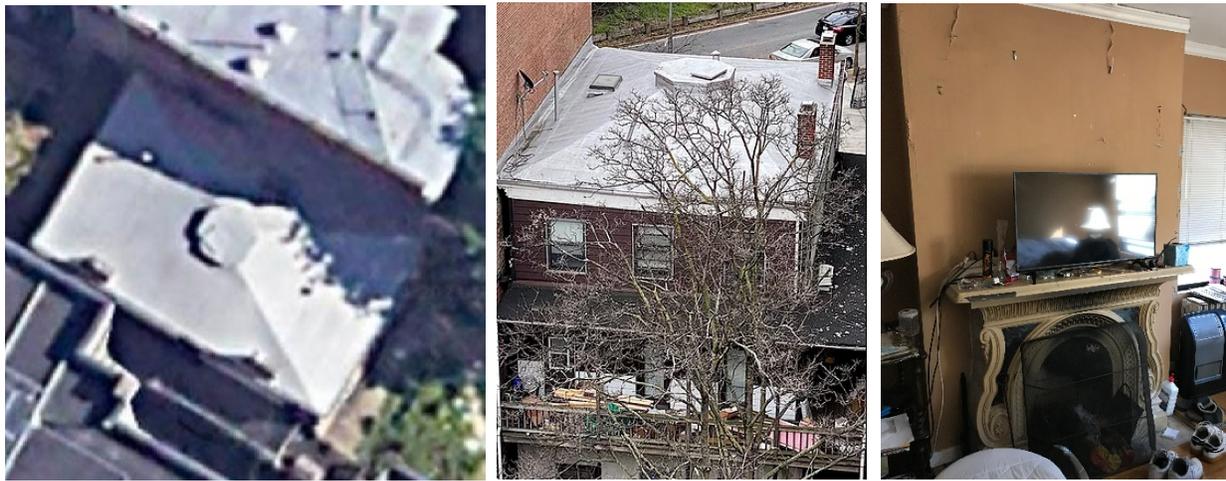
Figures 8-10: Aerial views of the roof and chimneys with corresponding chimney stack and fireplace on the interior

The building retains its original form and massing including hipped roof - characteristic of the italianate style - and two brick chimneys protruding from the southern part of the roof which correspond with two existing interior fireplaces.

Though these chimneys are lower than in historic photographs, their style and placement is significant as the construction is consistent with the 1850s. The framing for the cupola also remains in place as well as the original stairs which provided access to the cupola.

- Restoration of cupola based on historic photographs
- Restoration of chimneys to previous appearance
- Restoration of porch woodwork and details

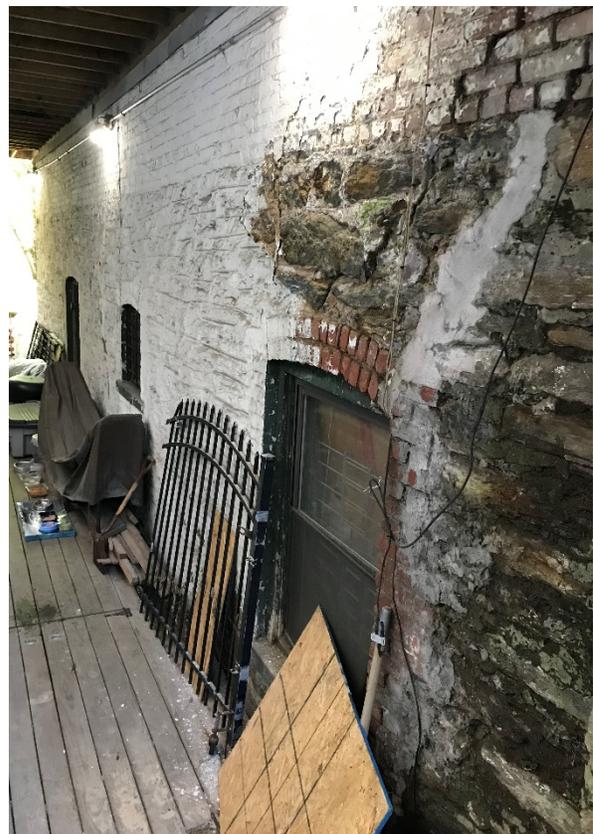
The historic foundation is most visible on the southern façade, which reveals early construction details including heavy rough-cut schist stone masonry up to the second level and brick coursing supporting a heavy wooden sill beam where the above ground two-story wood frame construction begins.

The foundation level features historic fenestration with brick arched lintels, wooden window frames, and stone sills. The foundation is parged in cement on the western façade.

Figure 11 detail of the foundation showing stone and brick coursing and historic windows.

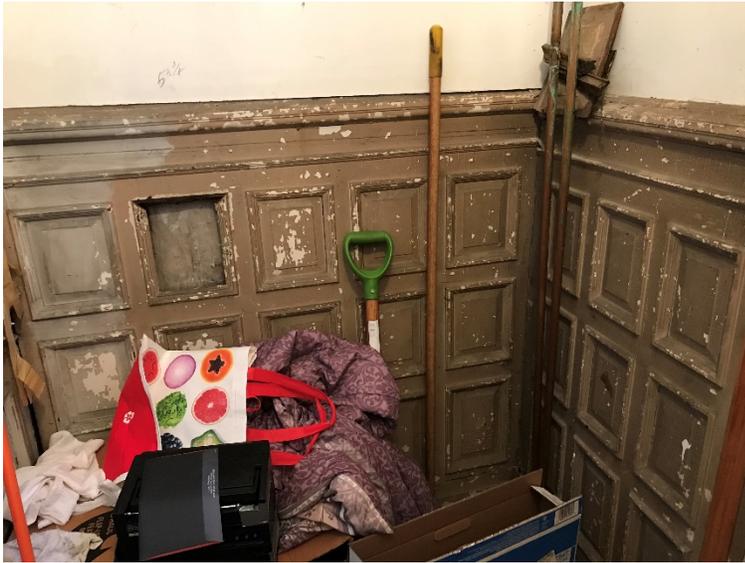
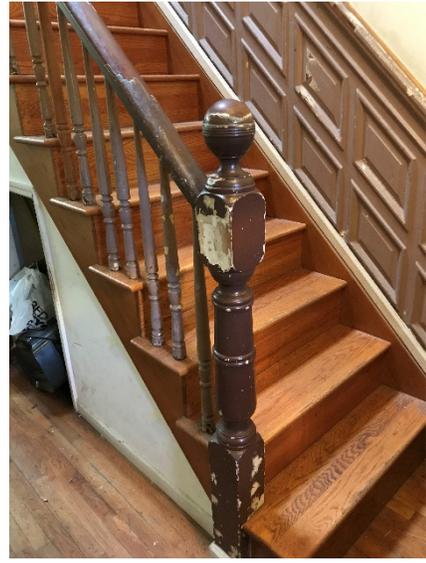
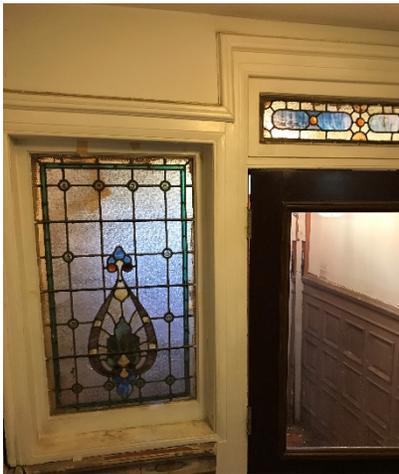
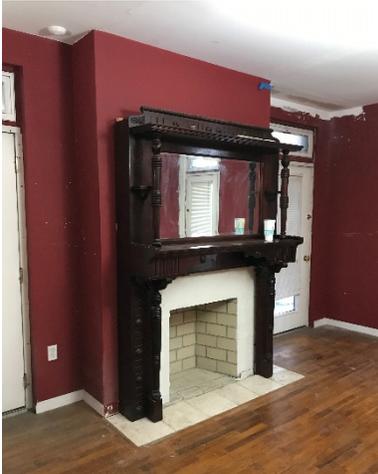
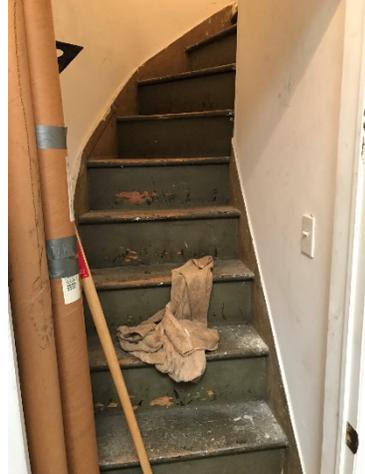
Figures 12-16 Clockwise from upper left: Wainscoting in the foyer, main stairs, stained glass at the entry, restored fireplace, original access stairs to the cupola.

The interior of 857 Riverside Dr. has been heavily altered over the years with significant renovations occurring around the turn of the 19th/20th centuries and during recent owners. Despite this, the interior retains some historic details and its layout has most likely not changed significantly since construction. Existing historic details include later 19th century wainscoting, moldings and stained glass, as well as the stairs, newel post and railing.

As previously mentioned the massing of the brick chimneys remains, though the fireplaces are later additions. The access to the cupola remains intact with spiral staircase winding around a custom-made wooden post.
